**ecology and environment, inc.**

July 27, 1998

Ref. No.: T190698-006  
TDD No.: 099804-001  
PAN No.: 0300PPSF-XX

Subject: **Pomona Plating, Site Assessment, Interim Report #2 and Final, Pomona, California****Introduction**

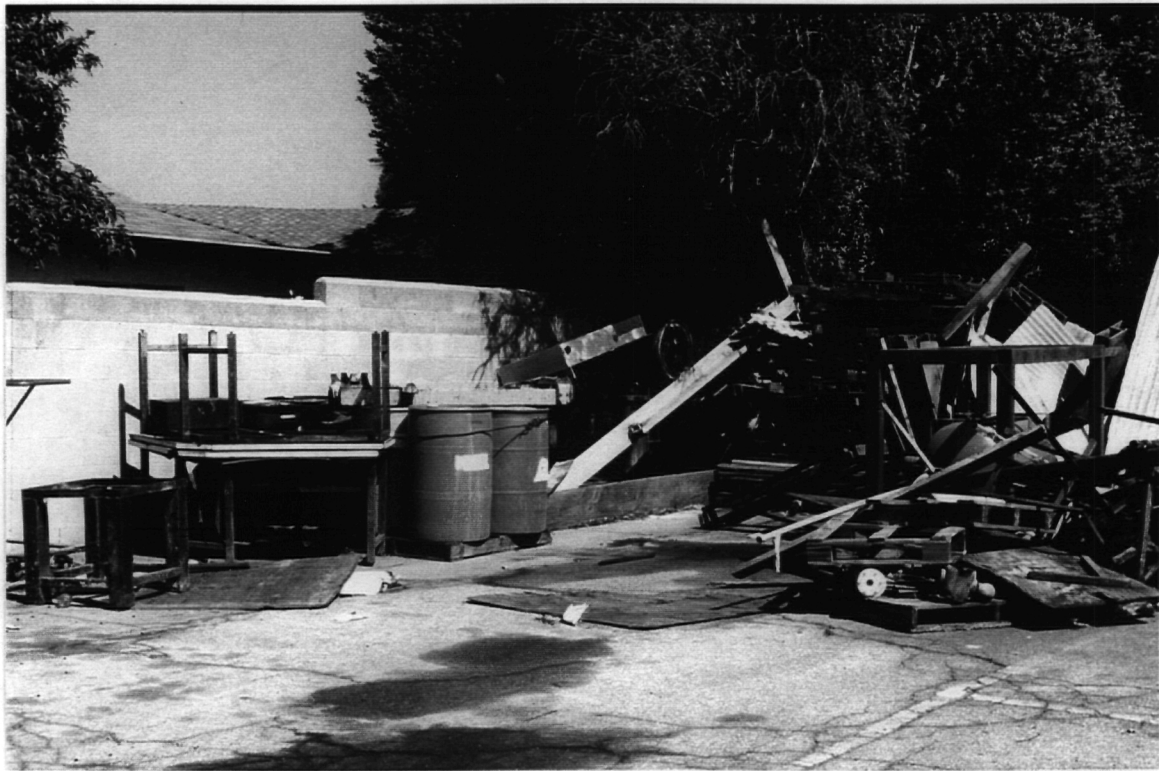
The western edge of the parking lot area (see Figure 1) contained miscellaneous scattered debris, fire damaged process equipment and empty vats, metal parts and empty containers. A total of nine full 55-gallon drums of wastewater treatment system additives and cleaning

Miscellaneous debris located in front lot, looking northwest.

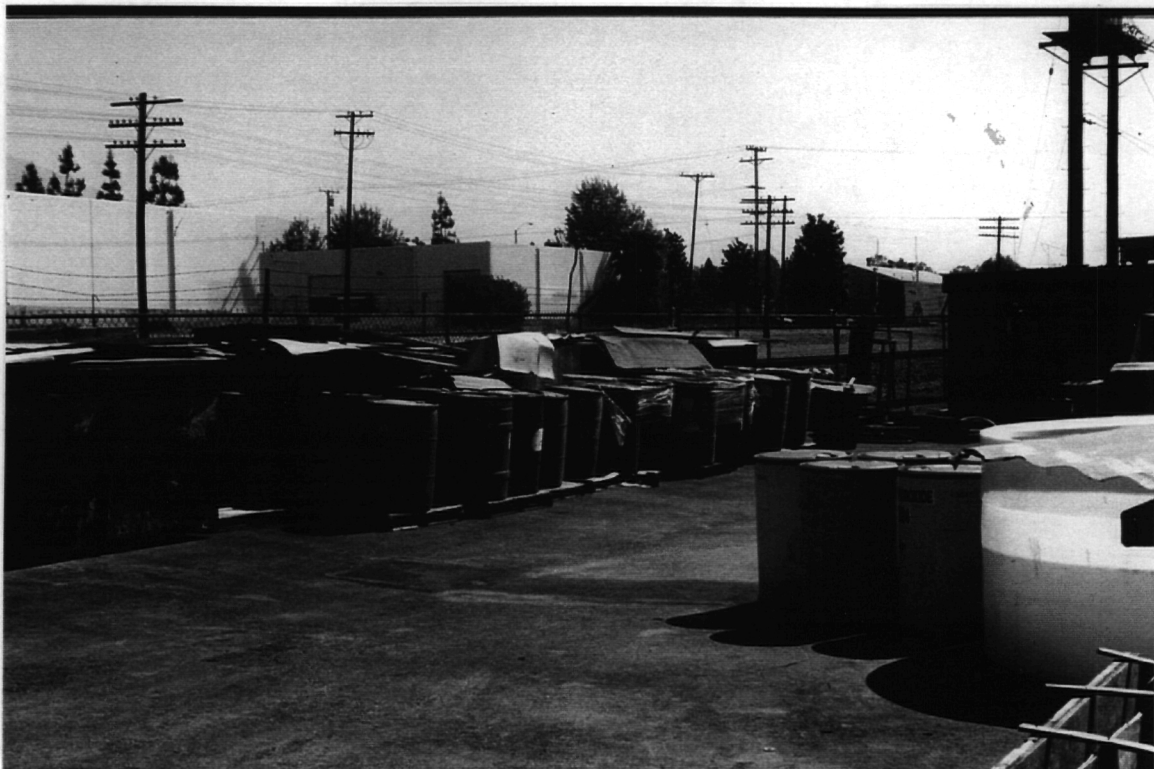
The 16 vats were generally lined up along the northern back lot fenceline. Only one was found to be empty and many were at or near their capacity with solutions. Many of the vats were completely exposed to the elements, while others were only partially covered with pieces of wood or plastic. Only two of the 16 back lot vats were marked with a description ("spent chrome" and good nickel liquid").

Approximately 48, 55-gallon drums with contents were also inventoried in the back lot. The majority of these were full and marked with a RCRA hazardous waste mark as "spent nitric or spent acid, D007". Accumulation start dates present on the marks were dated in late 1997. Several drums had written labels with the wording "chromic waste" and approximately six unopened drums contained product bleach or sodium hydroxide.

Drums and vats located in back lot/north property line, looking northeast.

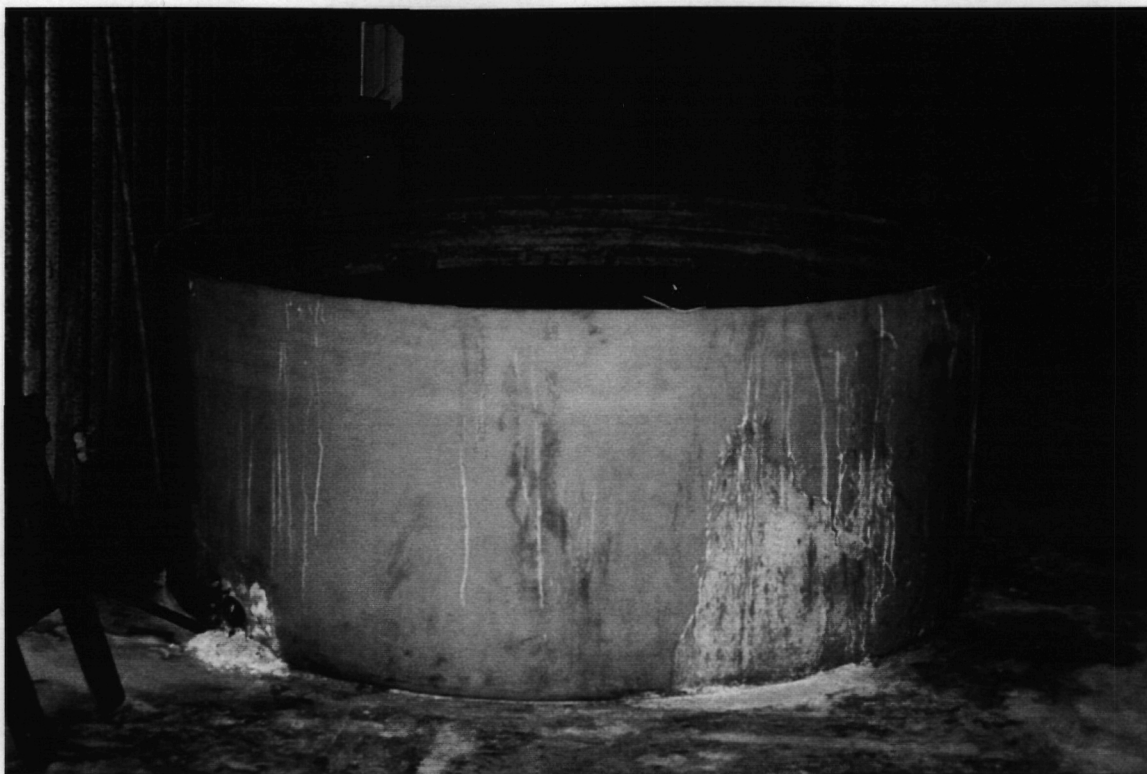
Tank containing waste acid rinse solution, located in main plating room.

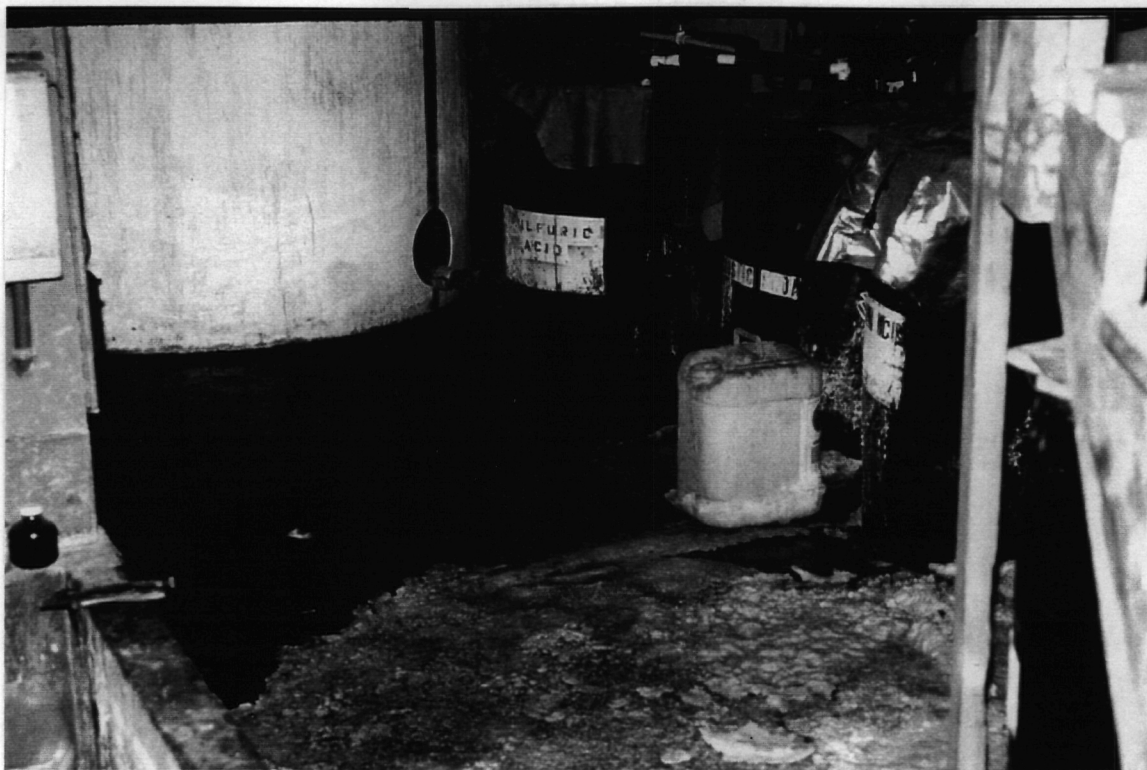
According to Mr. Sanchez, the system has not been utilized since December 1997. The total estimated quantity of wastewater treatment system liquids at the time of the assessment was 4, 560 gallons. There was an unquantified volume of sludge accumulated within the bermed wastewater treatment area.

Looking inside wastewater treatment area berm.

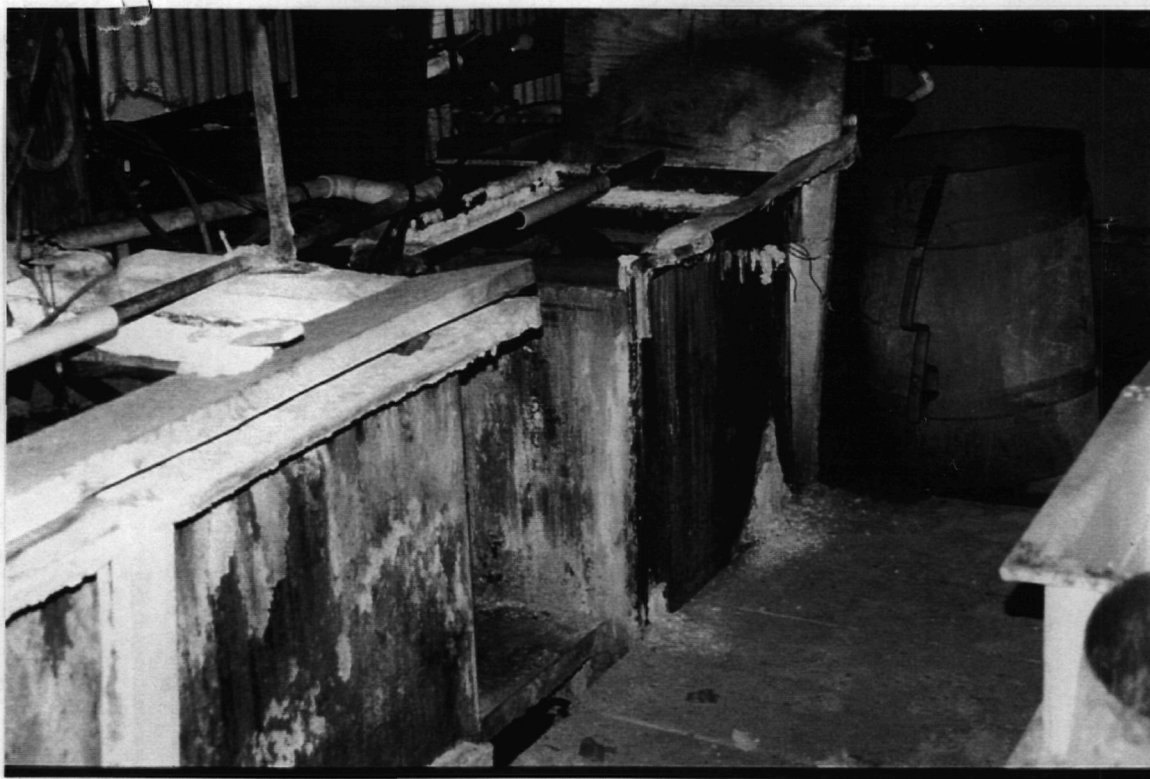
Tanks located along north wall of main plating room, looking west.

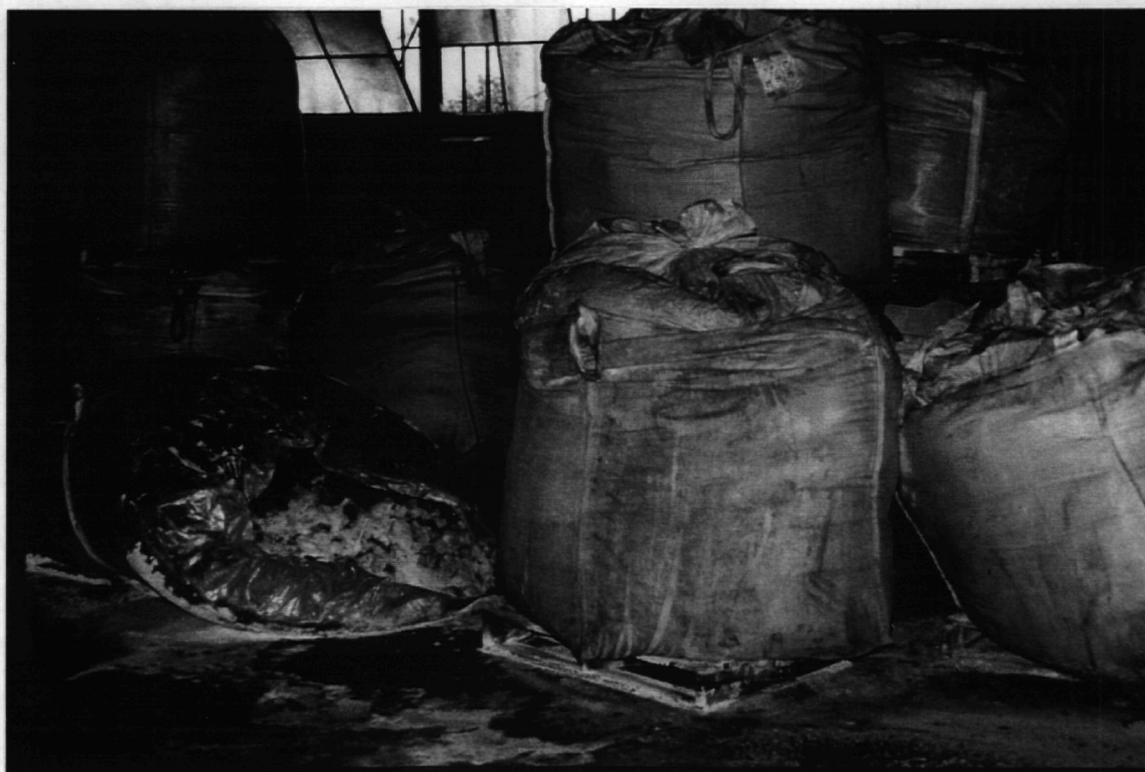
Eighteen 1-ton fiber woven "supersacks" full of filter cake were inventoried in the polishing room. Each sack was marked with a RCRA hazardous waste mark as "hazardous waste solid, n.o.s., 9, 3087, filter cake". The sheer volume of this filter cake indicates that appropriate off-site disposal had not occurred for some time.

Supersacks containing filter cake from wastewater treatment area.
